Imray Correction Notice ICA271-1

4 October 2023

Chart **A271** WGS 84

Edition 2017

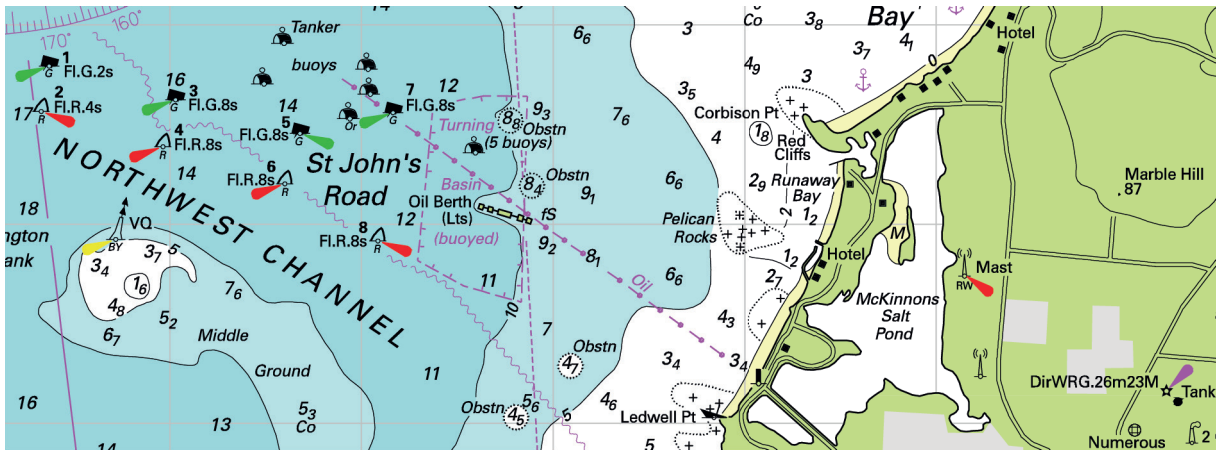
Block correction for A271
ILNW 543/19

4 Northwest Channel & Hog John Bay

Insert accompanying block correction centred on 17°08'·99N 61°51'·85W

Insert *Wk*, depth 1·0m in 17°07'·74N 61°52'·64W (ILNW 543/19)
