# Imray Correction Notice ICY17B-1

## Chart **Y17B** WGS 84

*Edition 2022*

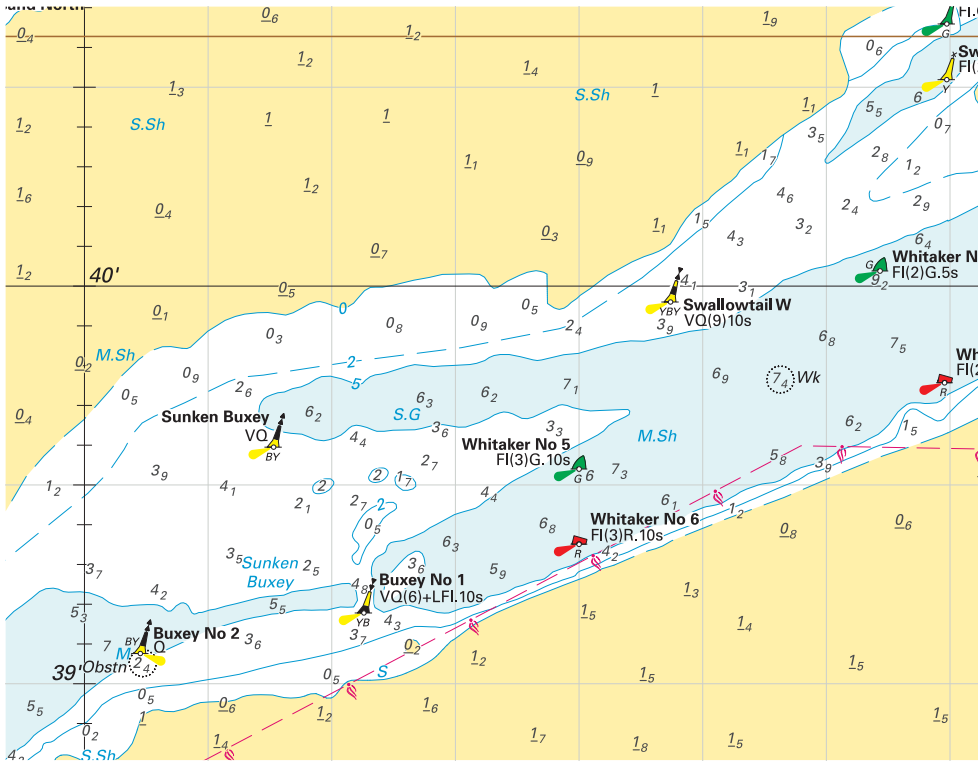
Block correction for Y17B  
 ILNW 20/23

#### 3 **Sunken Buxey, Approaches to River Crouch**

Insert accompanying block correction centred on 51°39'·76N 1°01'·65E (ILNW 20/23)
