Imray Correction Notice

2000 Series small format charts

IC2000-6

04 October 2018

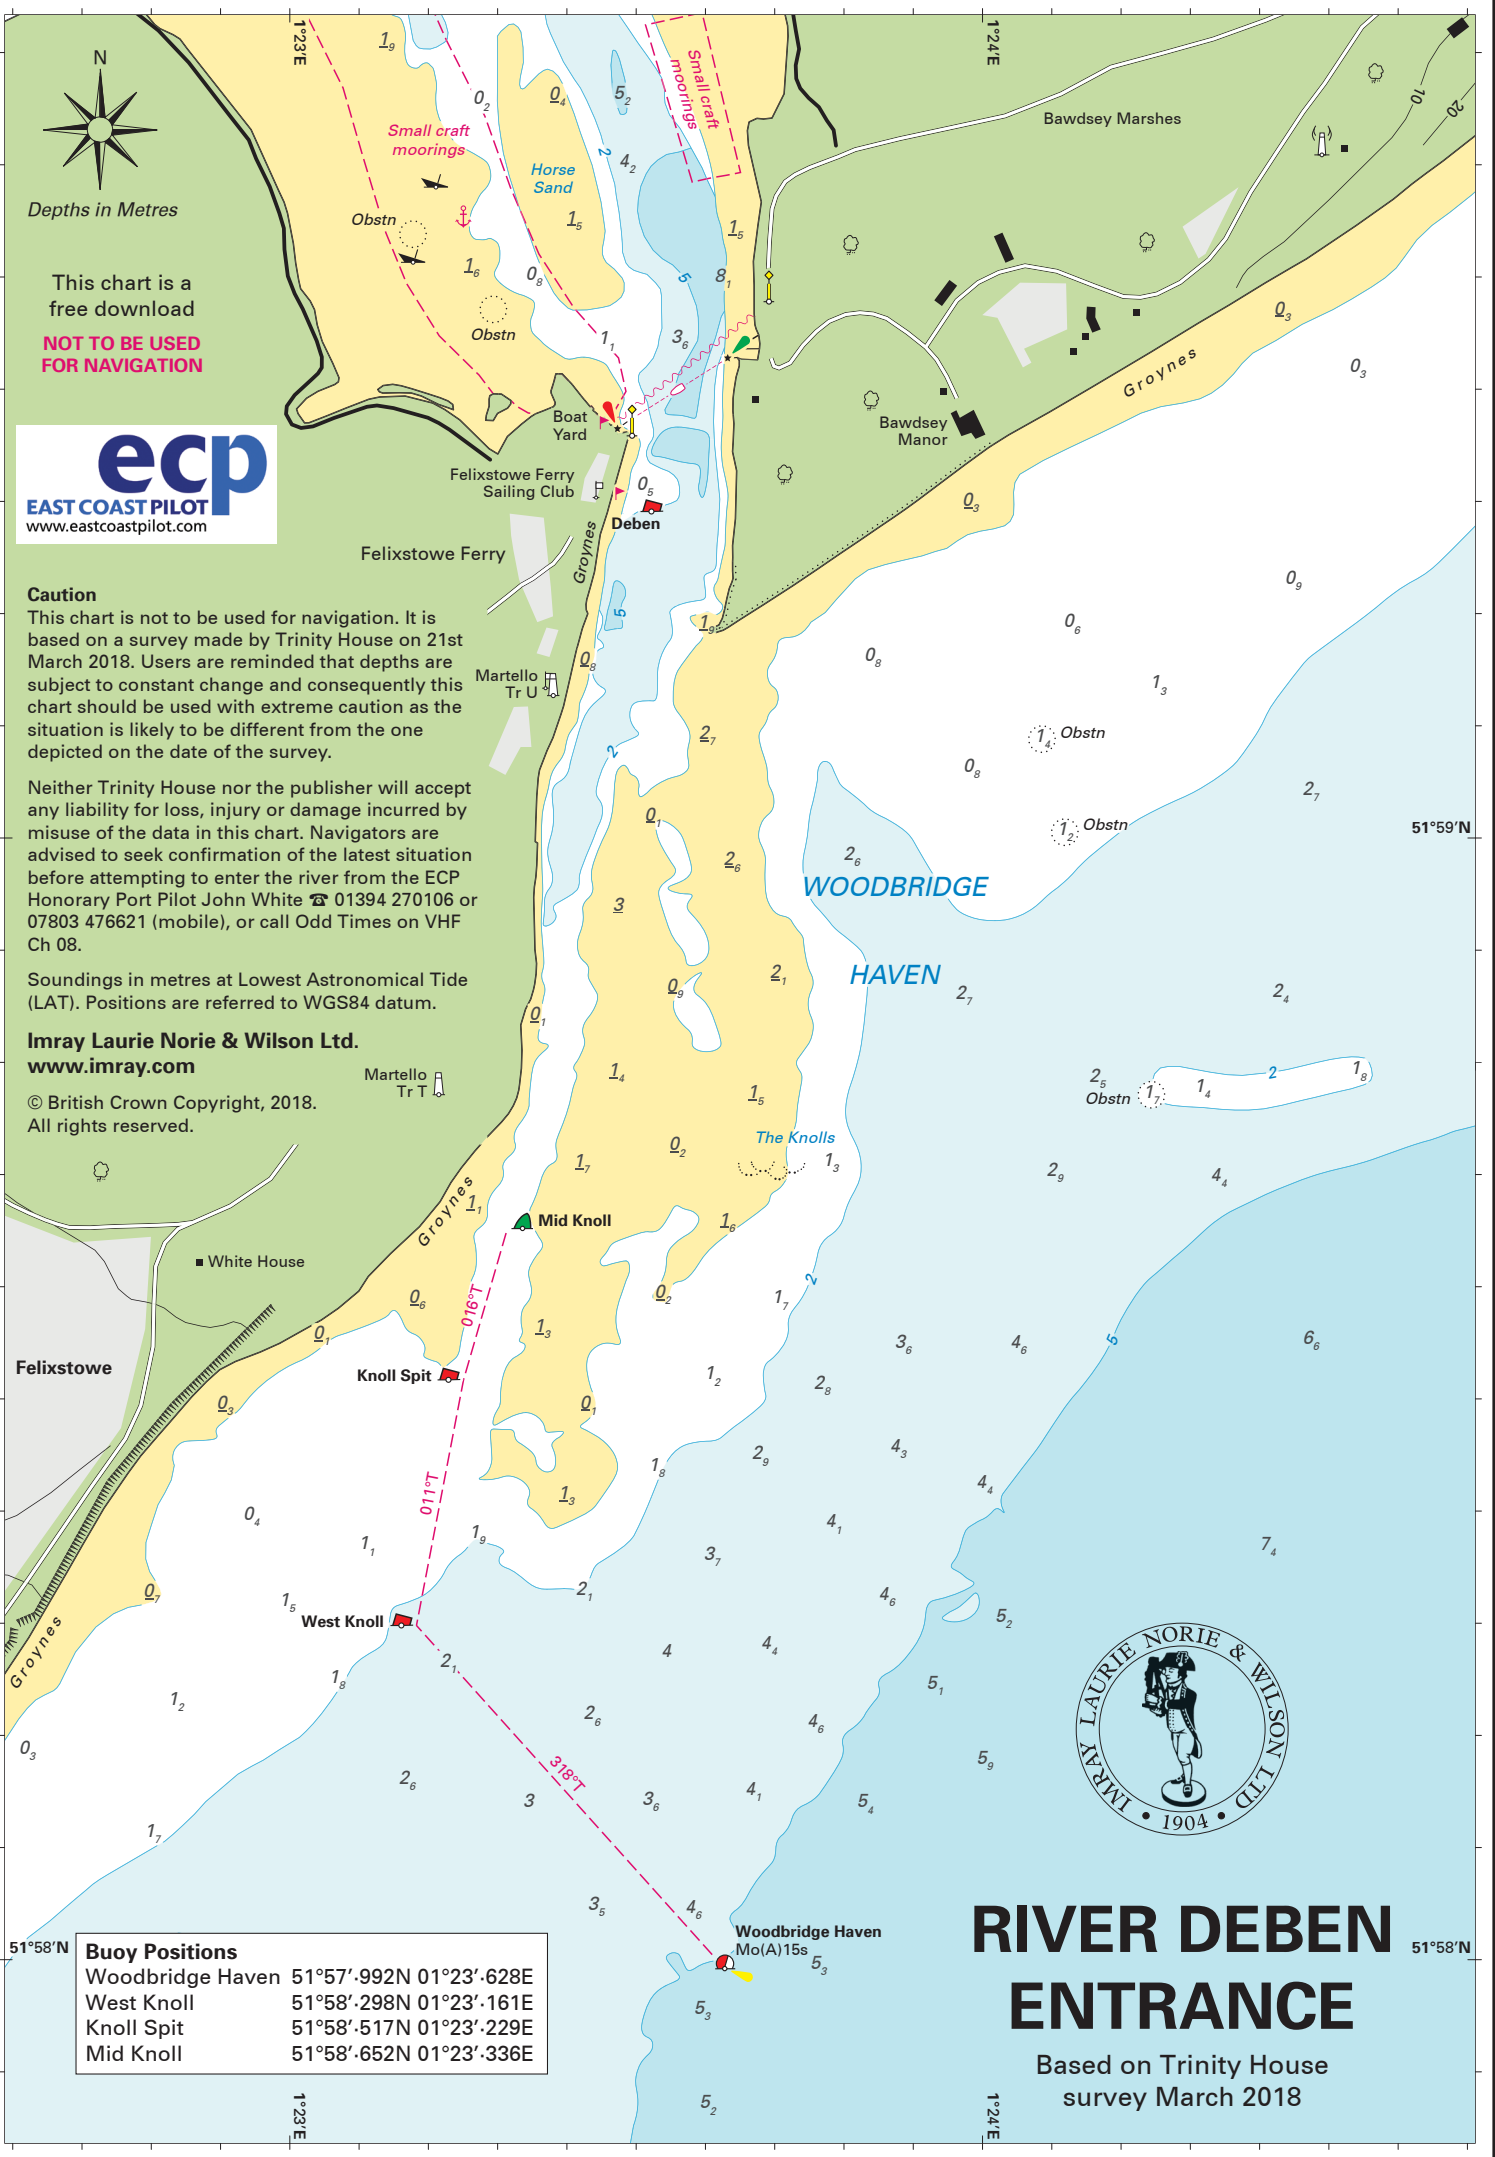
RIVER DEBEN ENTRANCE

Buoy Positions	
Woodbridge Haven	51°57'.992N 01°23'.628E
West Knoll	51°58'.298N 01°23'.161E
Knoll Spit	51°58'.517N 01°23'.229E
Mid Knoll	51°58'.652N 01°23'.336E

2 Woodbridge Haven

Move:

R can buoy **Deben** to 51°59'·29N 1°23'·52E

R can buoy **Knoll Spit** to 51°58'·52N 1°23'·23E

G con. buoy **Mid Knoll** to 51°58'·65N 1°23'·34E

For detailed information about the River Deben entrance yachtsmen are advised to consult the accompanying chartlet (revised 03/18) (ILNW 221/18)

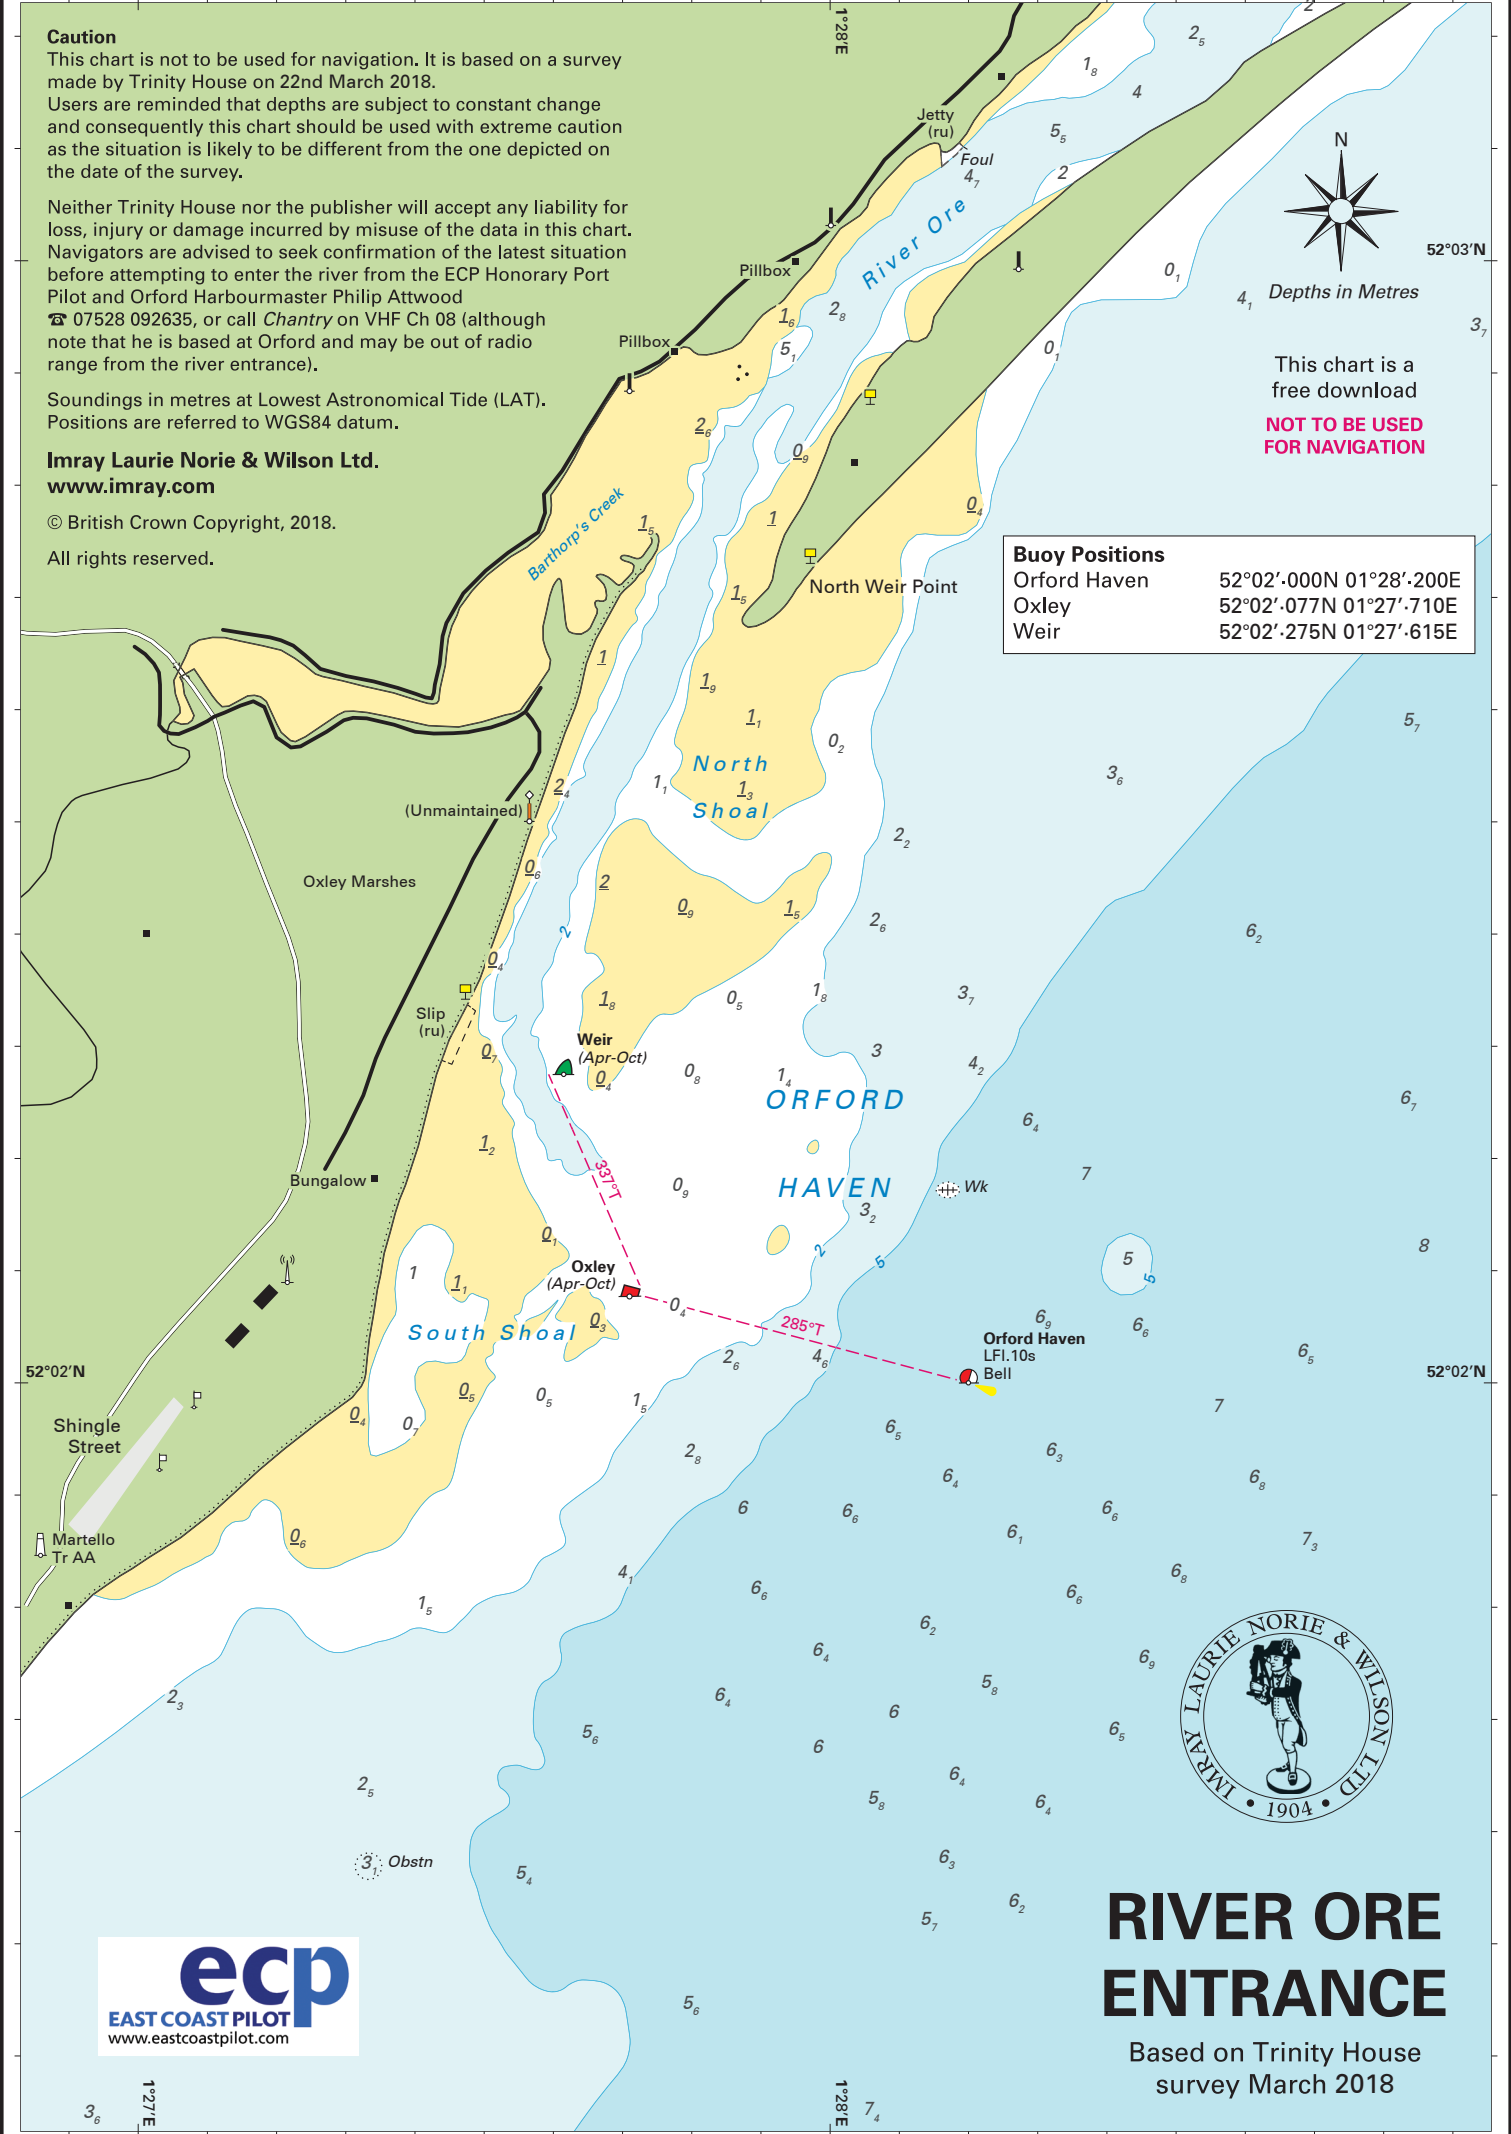
RIVER ORE ENTRANCE

Orford Haven	52°02'.000N 01°28'.200E
Oxley	52°02'.077N 01°27'.710E
Weir	52°02'.275N 01°27'.615E

1 Orford Haven

Move:

R can buoy **Oxley** to 52°02'·08N 1°27'·71E

G con. buoy **Weir** to 52°02'·27N 1°27'·61E

For detailed information about the River Ore entrance yachtsmen are advised to consult the accompanying chartlet (revised 03/18) (ILNW 220/18)
