# Imray Correction Notice

ICC48-3

## Chart C48 WGS 84

Edition 2015

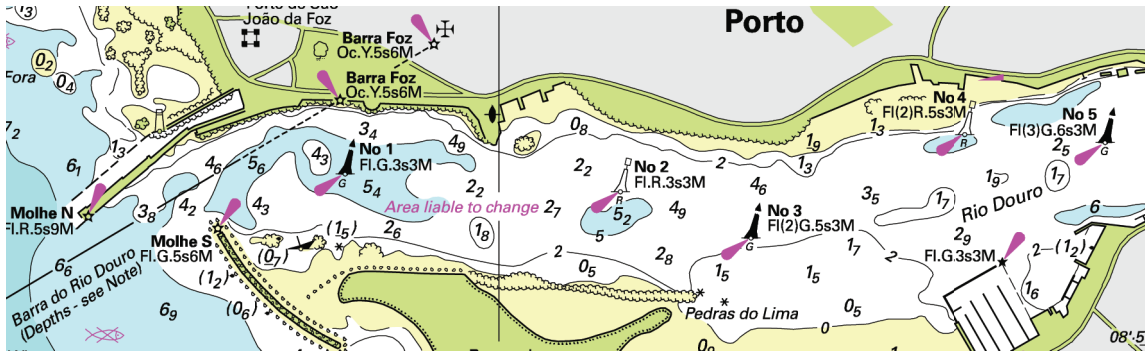
Block correction for C48 (Plan O)  
ILNW 310/16

Insert accompanying block correction centred on 41°08'·74N 8°39'·85W. (ILNW 310/16)
