Shell Channel Pilot

Revised 8th Edition 2021
ISBN 978 184623 700 3

Supplement No.6 July 2025

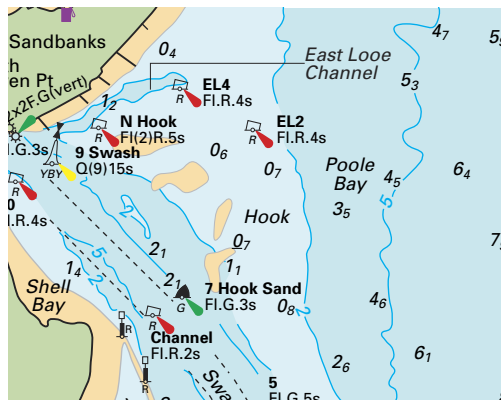
Page 134 East Looe Channel Poole

Mariners are advised that due to shifting sand bars it has become necessary to re-position buoys EL2 and EL4 as per the chartlet below.

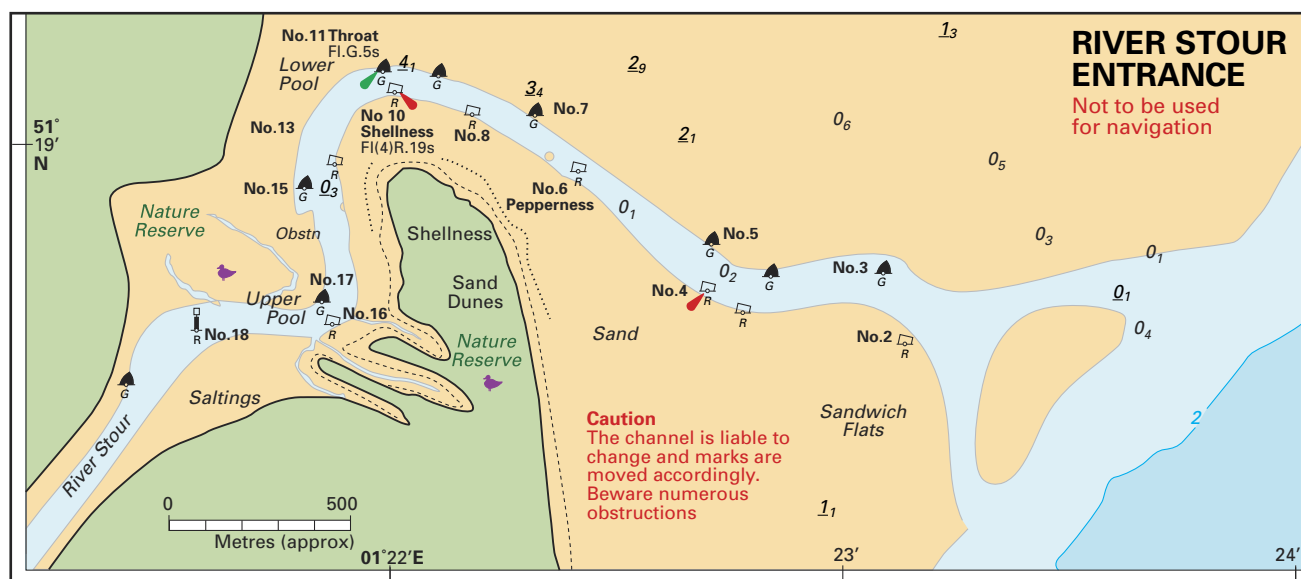
Page 27 River Stour entrance plan

See amended plan below.

Note that this plan is issued in good faith from data given by local users. It is the best available at the time of publication but cannot be guaranteed. For latest information go to <http://sandwichphc.uk/estchart.html>
