Imray Correction Notice ICY9-3

28 February 2024

Chart **Y9** WGS 84 Edition 2018

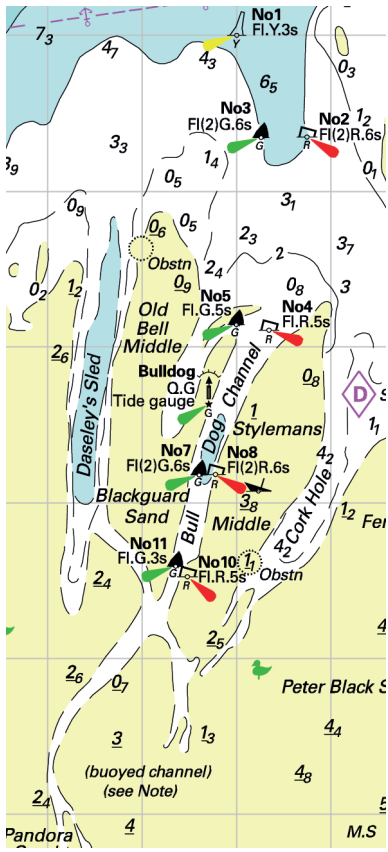
Block correction for Y9
 ILNW 175/22

Insert accompanying block correction centred on 52°53'·49N 0°22'·57E (ILNW 175/22)
